Structural Test Documentation and Results for the McDonnell Douglas All-Composite Wing Stub Box

Dawn C. Jegley and Harold G. Bush
Langley Research Center, Hampton, Virginia

April 1997

**National Aeronautics and
Space Administration
Langley Research Center
Hampton, Virginia 23681-0001**

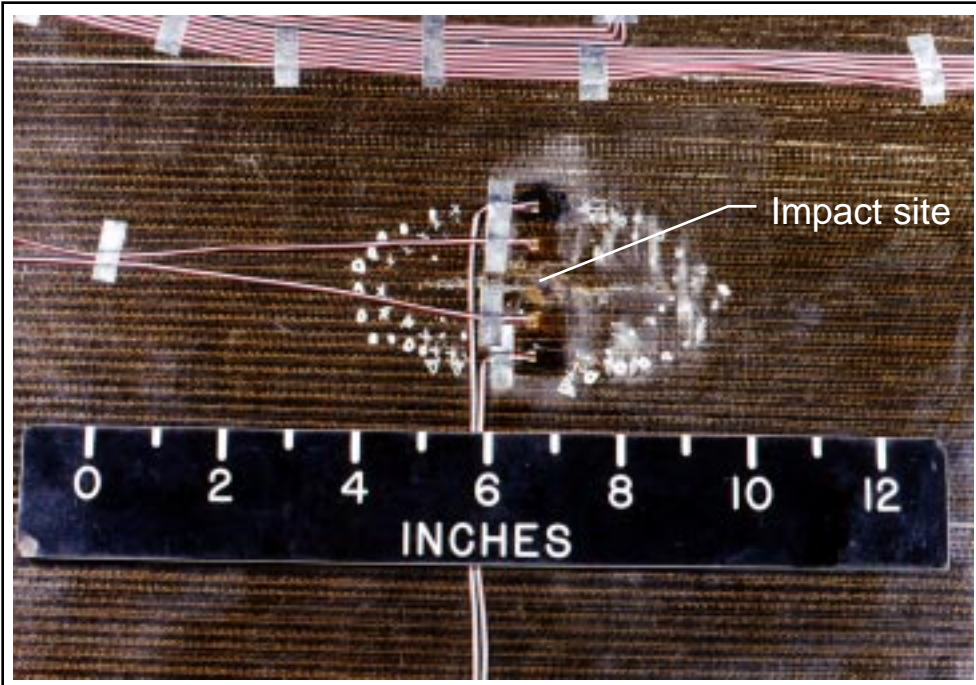
In order to limit the dent depth to 0.1 inches, the damage was inflicted by a series of impacts at the same location. Four impacts were required to inflict the required dent depth. After each impact, the dent depth was measured and the region of skin around the impact site was nondestructively evaluated by ultrasonic scanning to determine the area of the structure which had been damaged. The impact energies of the four impacts and their effects are shown in table 1. After the fourth impact, the dent was 0.093 inches deep and the damage area was defined by an oval with an axial dimension of 5.75 inches and a width dimension of 2.75 inches. No further impacts were made since further growth in the size of the damage area was not desired. The stringer flanges and blades of the upper cover panel were not damaged in the impact process. A photograph of the damaged region, with the region of damage outlined by white marks, is shown in figure 20. Damage was easily visible by eye.

Figure 20. Visible impact damage region DET1.

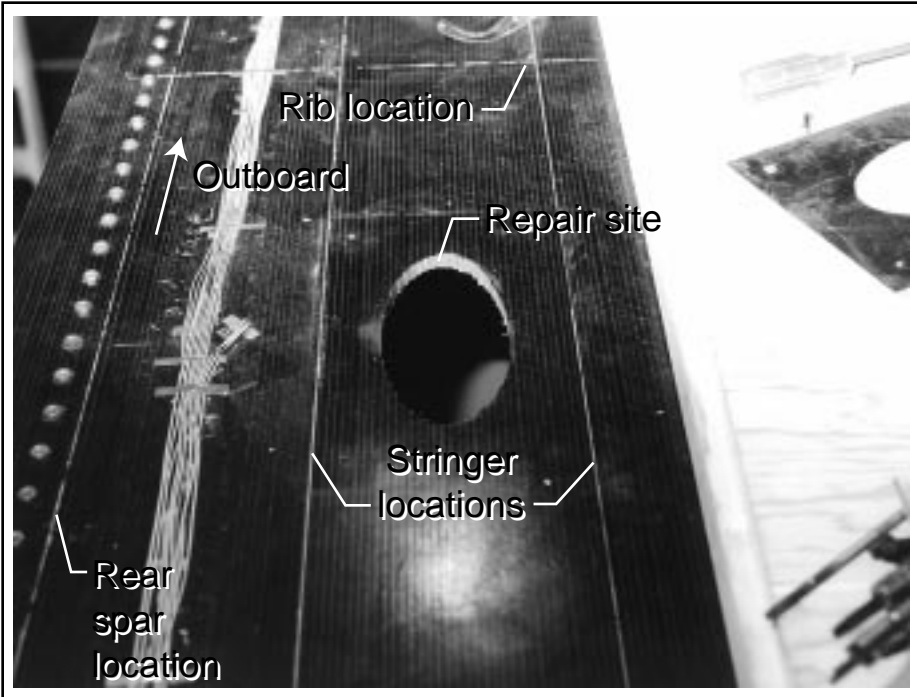
Figure 21. Upper cover panel prior to installation of repair.

A bolt-on metal patch was used to repair the upper cover panel. All materials for the patch were supplied by McDonnell Douglas Aerospace and personnel from American Airlines installed the patch. The structure was prepared for patch installation by cutting out the damaged section of skin, as shown in figure 21. The cutout was in the shape of an ellipse with dimensions 7.5 inches by 3.75 inches. The cutout was in the skin between stringers, as illustrated in figure 22. Bolt holes were drilled through the stringer flanges and skin. A 3/8-inch-thick aluminum plate was bolted to the external skin to cover the cutout. The plate dimensions were 11.7 inches by 7.28 inches. The completed repair is shown in figure 23.

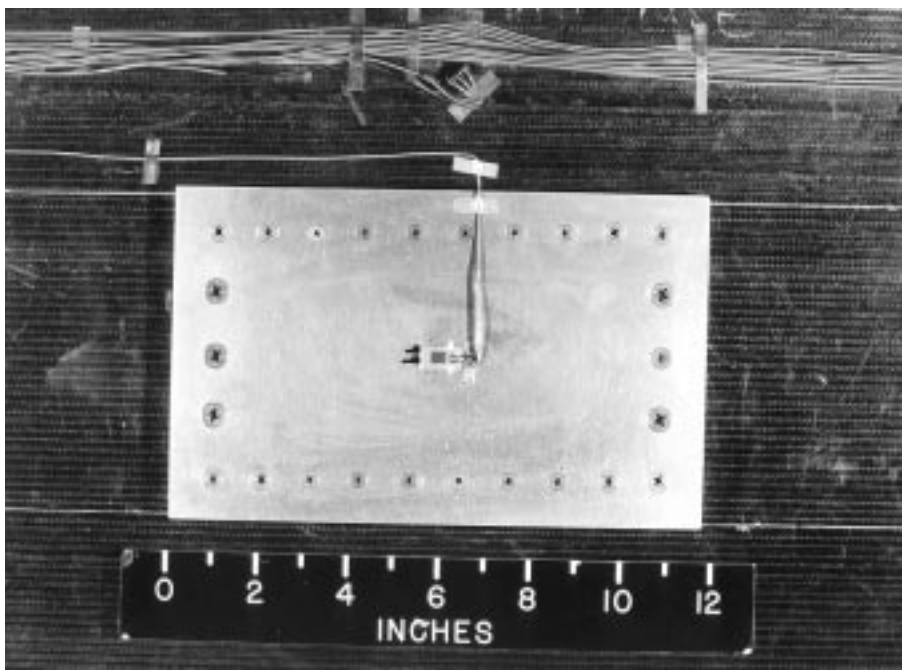
Figure 23. Completed repair.

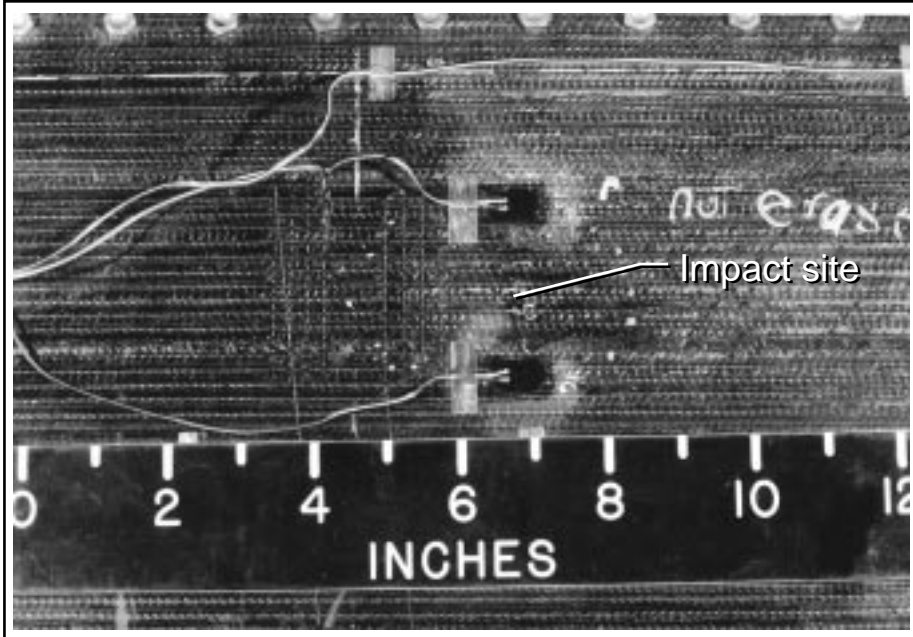
a) Impact region NDT1

A dropped-weight impactor was used to inflict nonvisible damage to the upper cover panel at two locations. An impact energy of 100 ft-lb was used to inflict the nonvisible damage. These impact sites are at a stiffener runout near the front spar and at the edge of a flange near the rear spar. The front and rear impact sites, labeled NDT1 and NDT2, respectively, are shown in figure 5. The damage area in the upper cover panel skin around each damage site was determined ultrasonically and that area was marked on the upper cover panel. Photographs of these damage regions prior to testing are shown in figure 24. The damage area at location NDT1 is an oval with dimensions of 4.0 inches by 3.0 inches. The damage area at location NDT2 is approximately "L" shaped with dimensions of 4.0 inches and 3.0 inches. The dent depth for the dent at location NDT1 is 0.014 inches. The dent depth at location NDT2 is 0.0134 inches.

No fiber breakage was visible on the outer surface of the structures and the dents were difficult to detect by eye. There was no way to gain access to the interior of the wing box at these locations to evaluate any possible damage to the interior structure, such as intercostals and stringers, prior to testing.

Figure 24. Nonvisible impact damage sites.

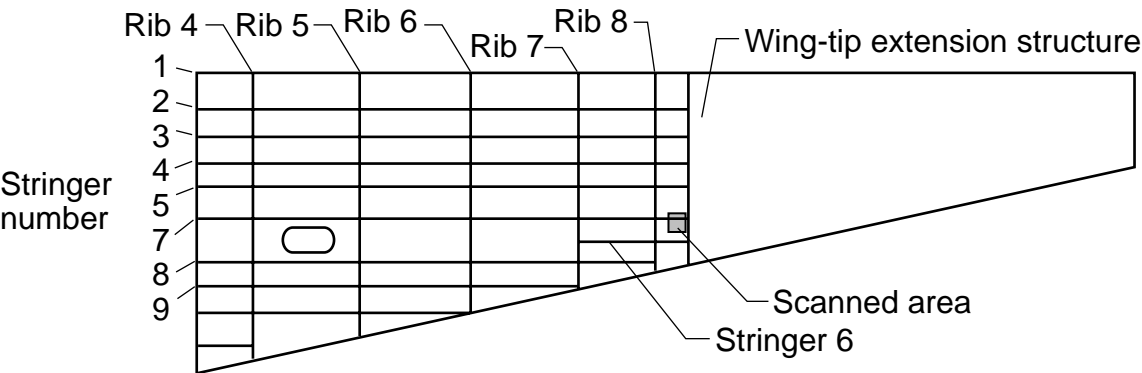
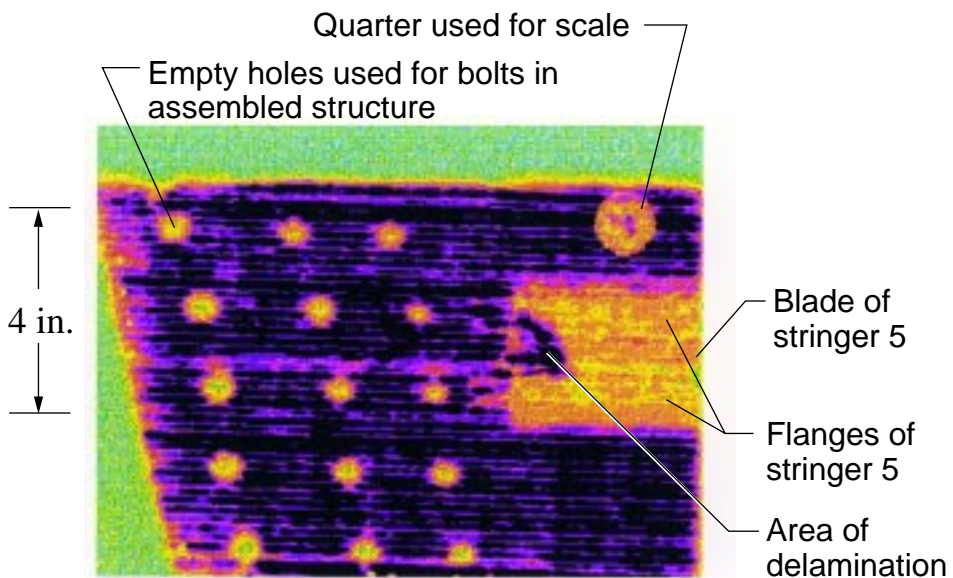
Figure 43. Damage area for upper cover splice on stringer 5.

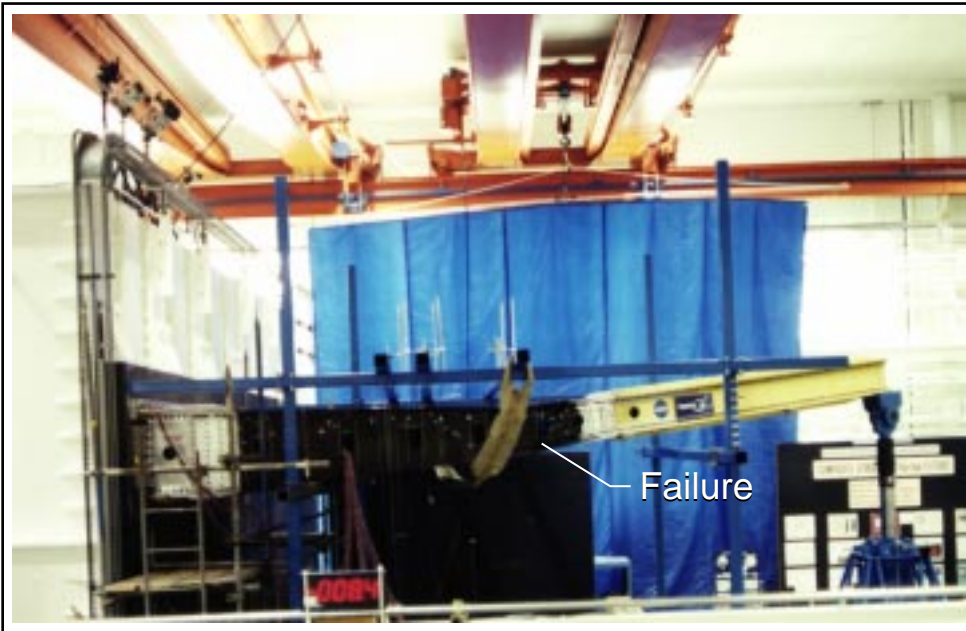
The maximum load supported by the structure at failure was 154 kips. A view of the entire structure after failure is shown in figure 63. Failure occurred across the entire width of the upper cover panel and into both spars. The lower cover panel skin remained intact. Photographs of the failures in the upper cover panel, and in the stringers between ribs 7 and 8 are shown in figures 64 and 65, respectively. Two independent failures occurred in the wing stub box. The first failure was in the unsupported region at the runout of stringer 6 where it terminates at rib 7 at a load of approximately 140 kips. During the test, the flanges and web of the stringer failed and the skin remained intact. This stringer has extensive damage in the form of delaminations between the skin and flange, broken stitches, bolts pulled through the flange, and cracking of the blade, as shown in figure 65b. The second failure was catastrophic and initiated at the nondetectable impact damage site at the runout of stringer 7. This failure began at a load of approximately 145 kips. This failure resulted in a crack that runs across the upper cover panel through impact damage site NDT2, as shown in figure 66, and across the upper cover panel into the spars. Failed stringers aft of the impact site are shown in figure 65a.

Figure 63. Side view of test specimen after failure.

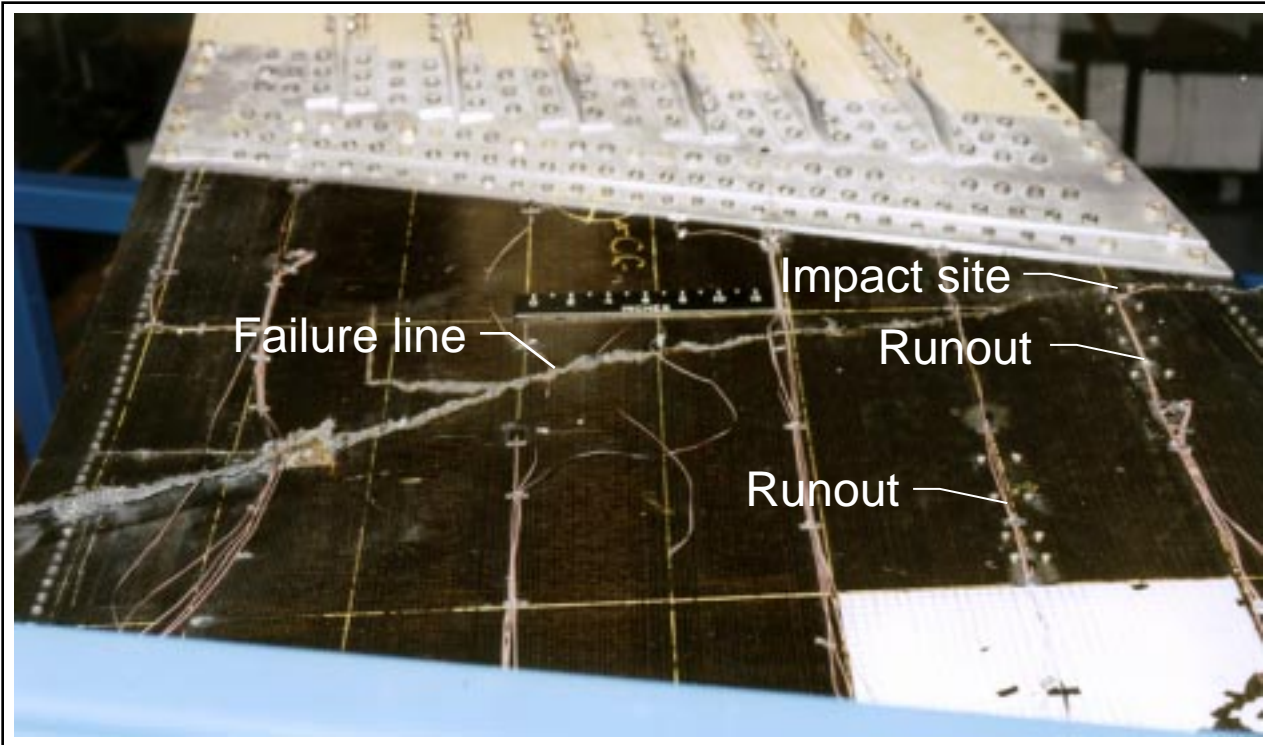
Figure 64. Upper cover after failure of test specimen.

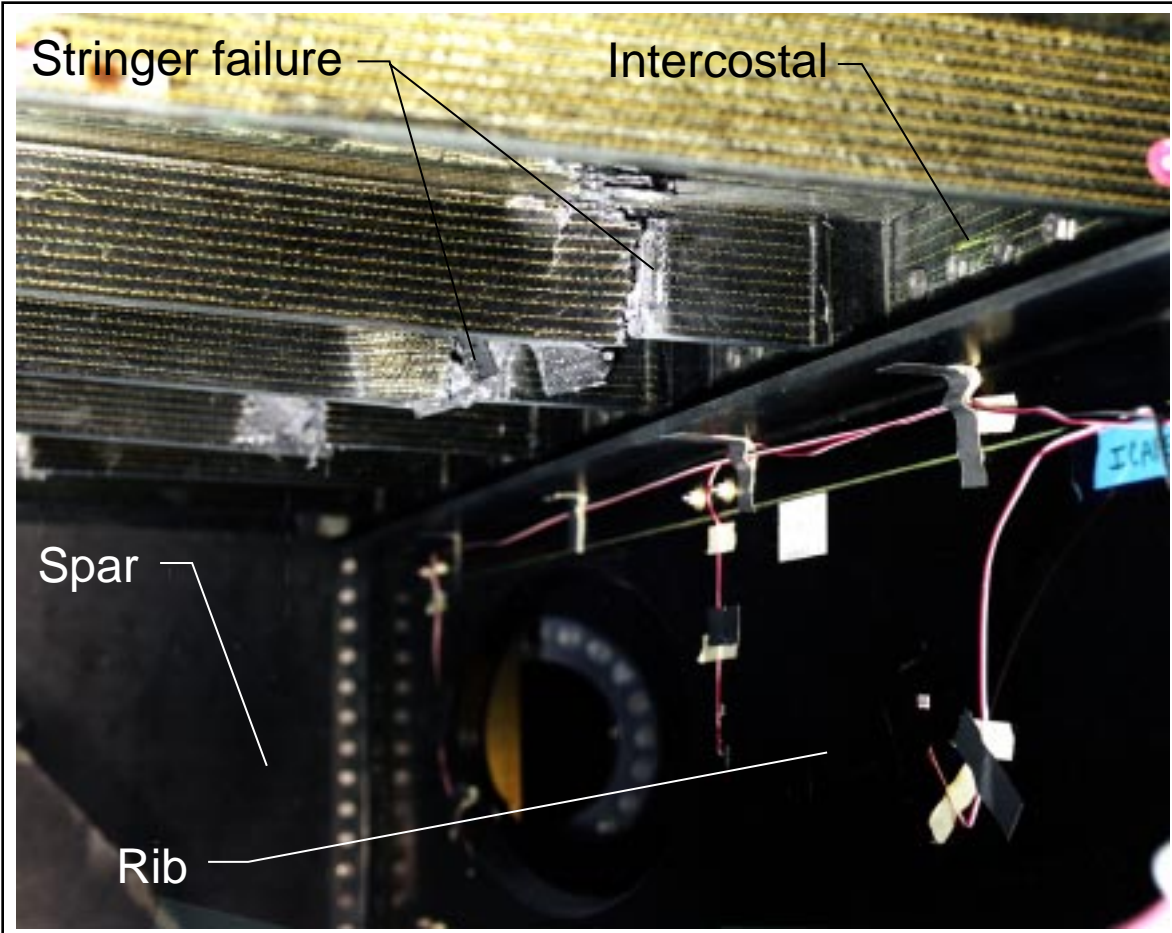
a) Failed stiffeners in upper cover panel

Delamination between the flange of stringer 5 and the upper cover panel skin inboard and outboard of rib 7 were also found, although the stitches between the flange and skin remained largely intact. Stringer 5 is on one edge of the unsupported skin region. This type of damage was not found in stringer 7, which is on the other edge of the unsupported skin region.

Figure 65. Failed upper cover panel stiffeners.

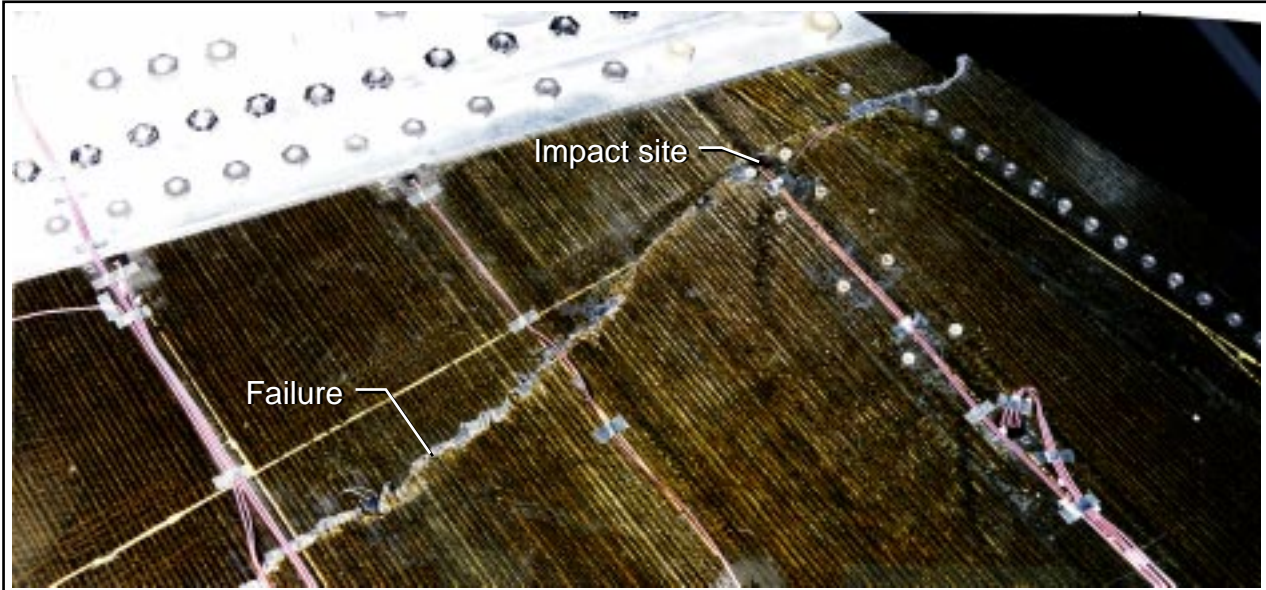
A series of tests were conducted on a McDonnell Douglas all-graphite-epoxy wing stub box to evaluate its structural performance. The structure supported Design Limit Load with no damage and with visible damage in the form of a 0.1-inch-deep dent to the upper cover panel skin. The structure supported 140% of Design Limit Load with nonvisible damage in the form of damage from 100 ft-lb of impact energy at two locations on the upper cover panel, and a repair of the visible damage. The failure of the structure involved large out-of-plane deformations in the wide upper cover skin bay outboard of the access door. These deformations caused failures in the stiffener terminating in that region. Final failure of the upper cover panel initiated at the nondetectable impact damage site and consisted of a large crack that propagated across the width of the panel through the impact damage site and into both spars.

Figure 66. Failure through impact damage site NDT2.
